**Lead-Based Paint and Asbestos Investigation Report
for
Jasper Power Plant
1163 East 15th Street
Jasper, Indiana 47546**

April 28, 2015

Cardno ATC Project No. 170IN1503H

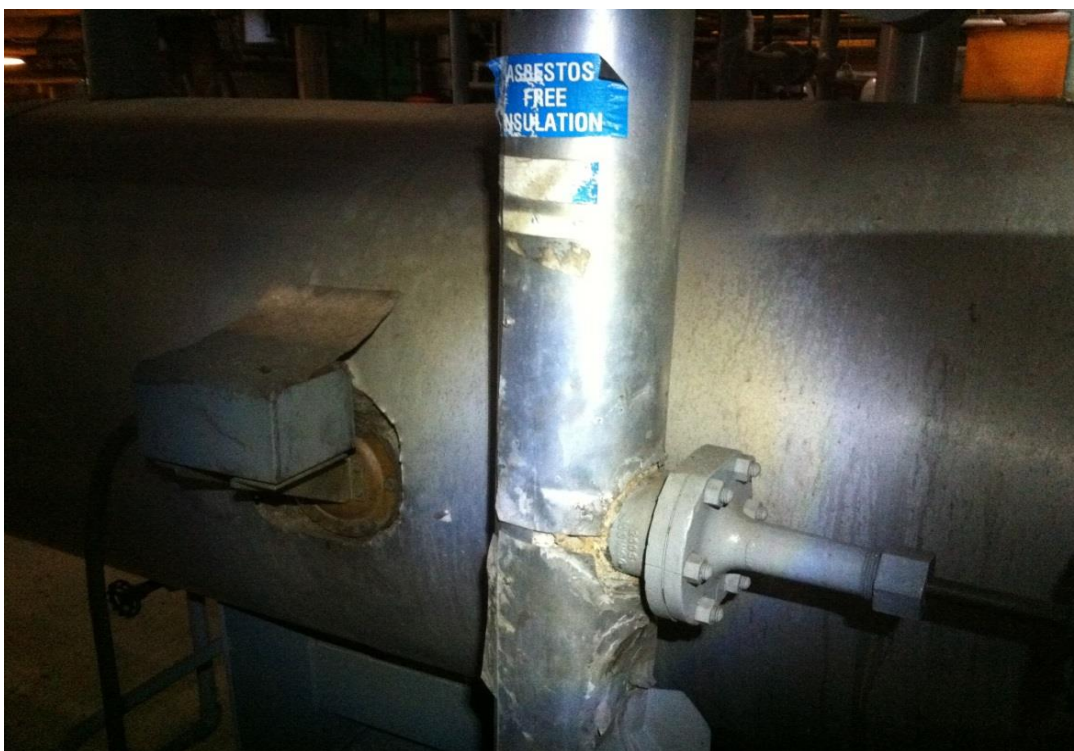
4 -

White Pipe Insulation in Plant Basement

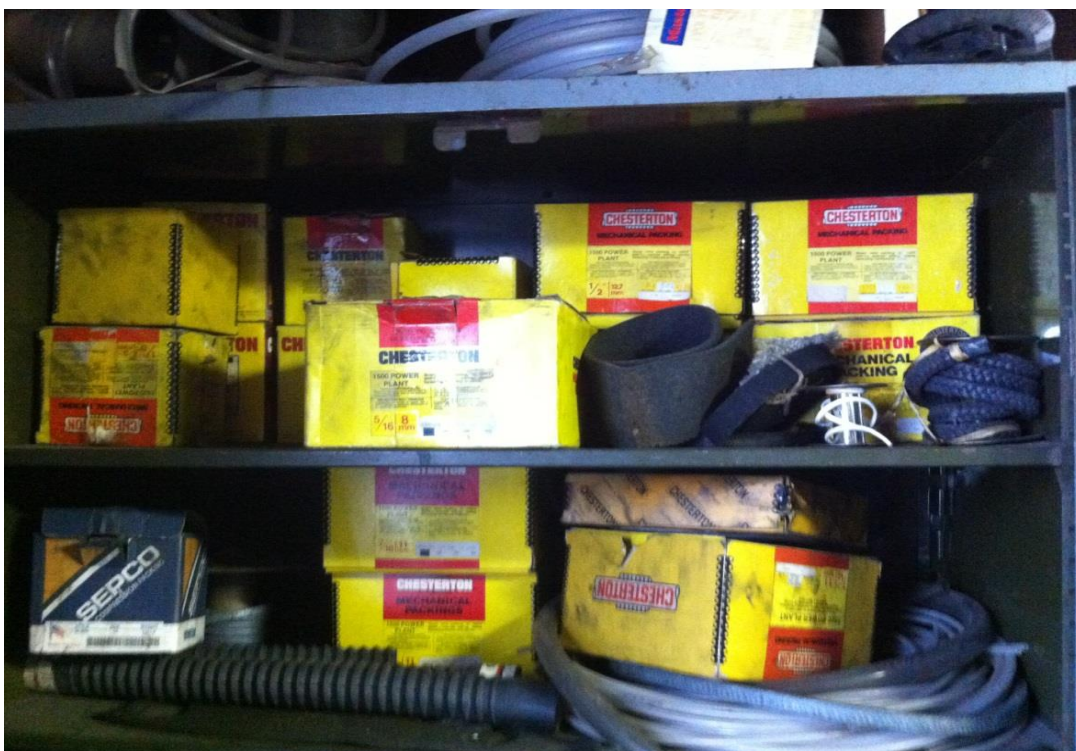
6 -

Stored Packings in Maintenance Building

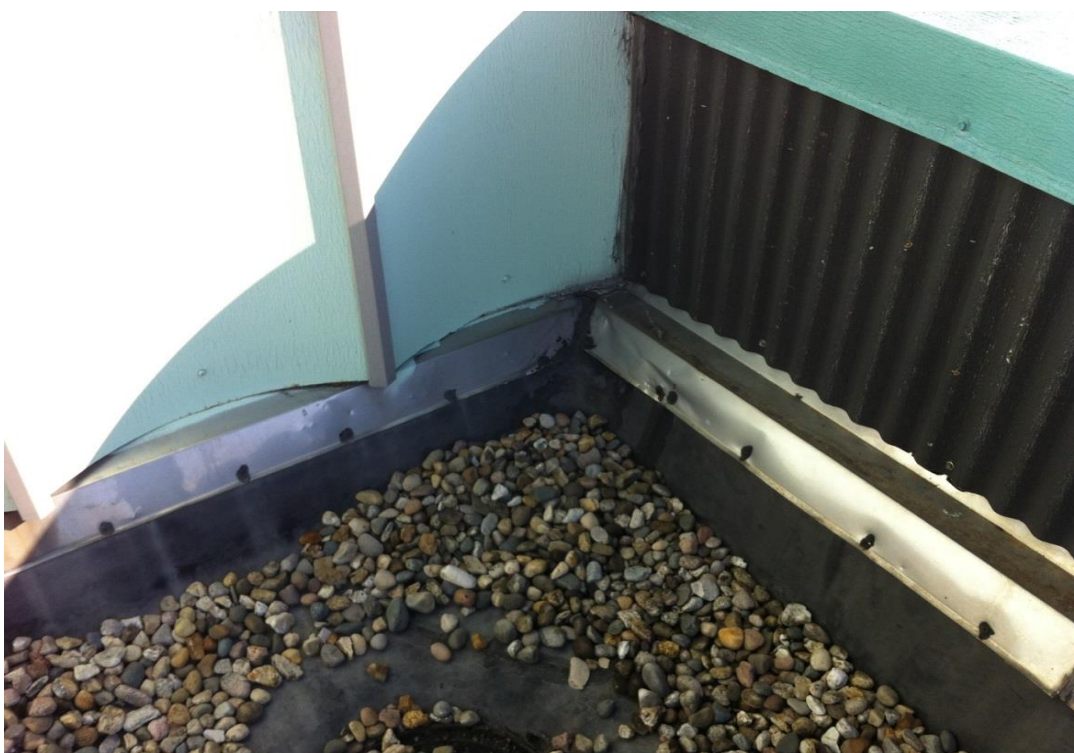
8 -

JPP-116	93	Gray Wall Coating	Plant Exterior - Fourth Floor West Roof
JPP-120	97	White Hard Pack Fitting	Plant Basement-Condensate Return Tank
JPP-121	98	White Hard Pack Fitting	Plant Basement-Bottom of Air Injector
JPP-123	100	White Hard Pack Fitting	Plant First Floor-Feed Pump Area
JPP-124	101	Brown Hard Pack Fitting	Plant First Floor-Steam Feed Pump
JPP-130	107	White Hard Pack Fitting	Plant Second Floor-Emergency Water Line
JPP-131	108	White Hard Pack Fitting	Plant Second Floor-Heating Steam Line
JPP-135	111	Gray Joint Caulk	Plant Third Floor-D.A. Tank Control Valve

View of Gray Wall Coating on Plant Exterior
